CASE STUDY 20901

AEROSPACE

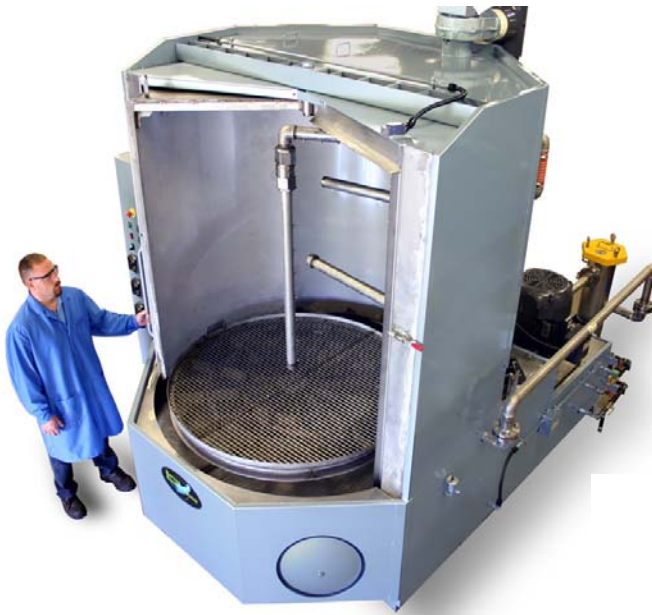
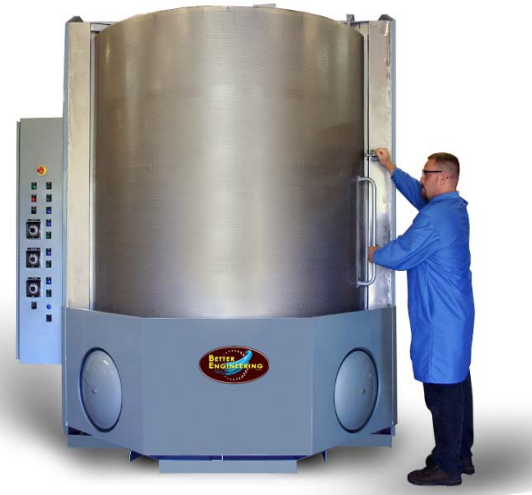
A F-RD-6000-PCS jet washer... During the fully automatic cleaning cycle, the parts are washed, air knives blow-off most of the wash water, and then the parts are rinsed at a 150 GPM. This two(2) tank system has a 60" diameter turntable and 60" work height.
